## Environmental Appraisal

# Technical Appendix 9-1 Woolfords Wind Farm Cultural Heritage

November 2021

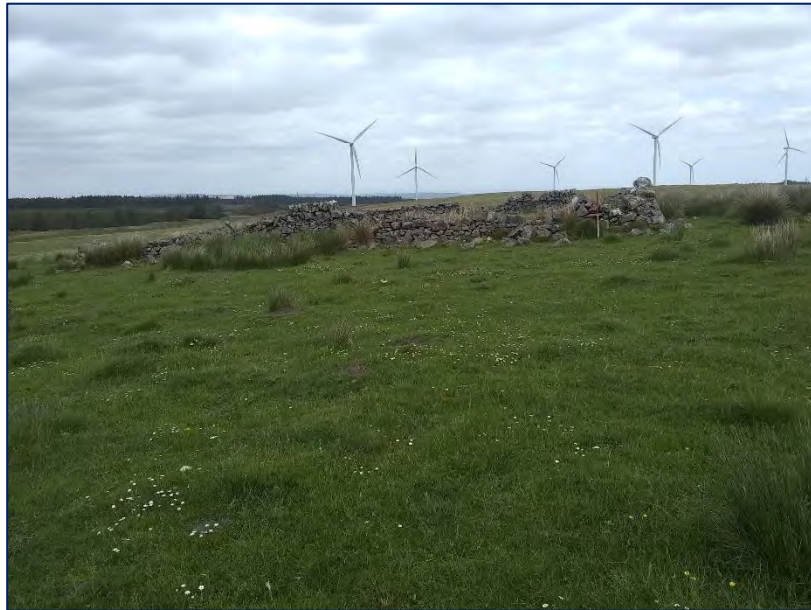
Plate 3: North-east facing view of the sheepfold at Site 32

The sheepfold at Site 32 (Plate 3), located 265m north of the proposed access track, was found to be a fairly substantial, sub-square in plan, dry stone walled upstanding feature. Some decay and damage to the sheepfold (Site 32) were identified and it no longer appears to be in use.

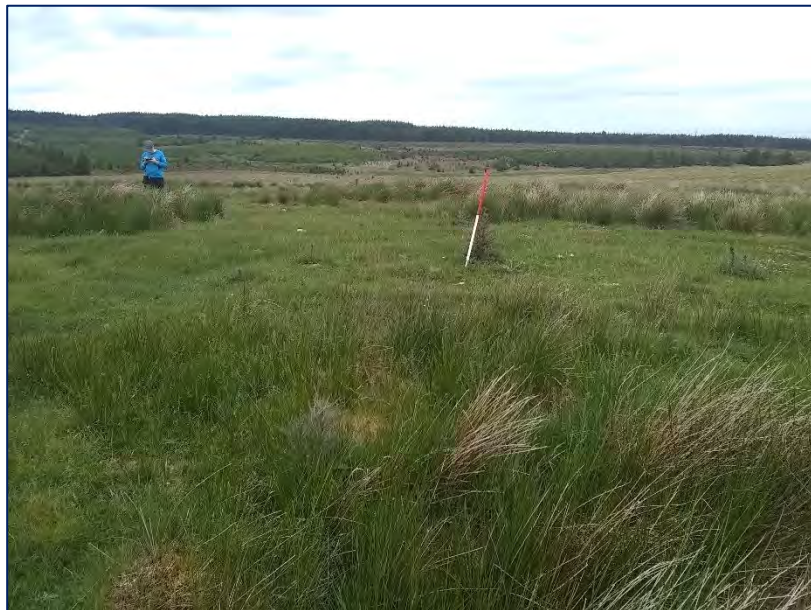
Plate 4: North facing view of the sheepfold at Site 90

The sheepfold at Site 90 (Plate 4), 103m west of the access track between Turbines 1 and 2, was also found to be a dry stone wall construction, square in plan and survived as an upstanding feature. The sheepfold (Site 90) no longer appears to be in use and decay and damage were noted to the feature.

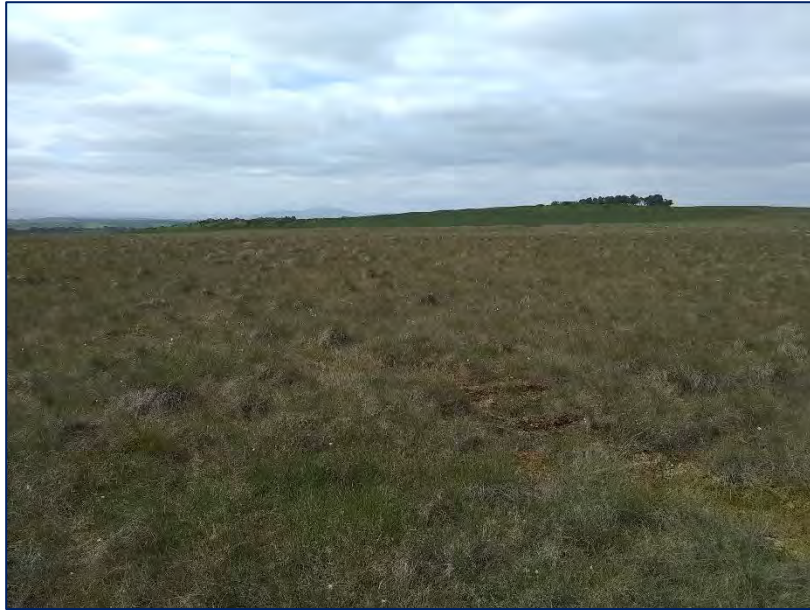
Plate 5: West facing view of the potential sheepfold at Site 96

Stone remains were identified along the north-western area of the feature and stones roughly marked out what appears to be the remains of a sub-circular structure (c. 12m in diameter). Stones were also identified in the wider area. It is thought that the remains at Site 96 may locate an earlier, smaller sheepfold or sheep pen which was replaced by the larger sheepfold at Site 90.

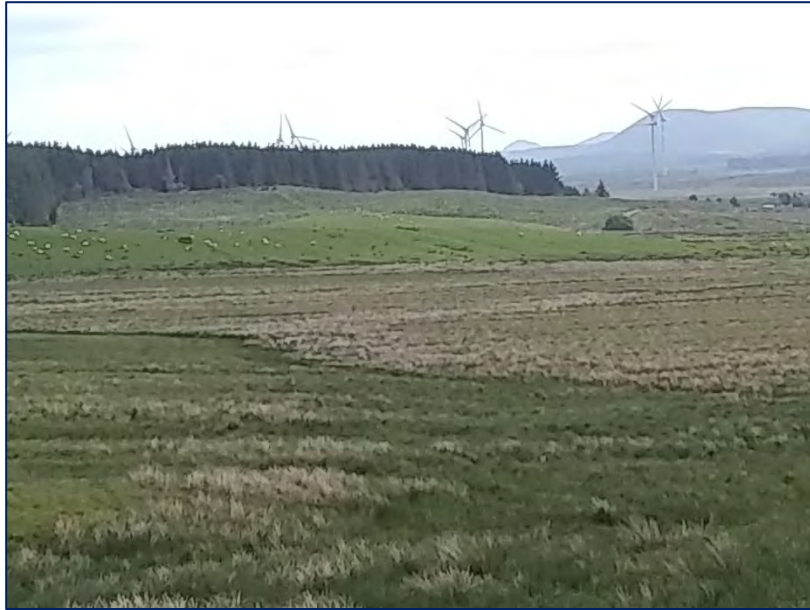
Plate 7: South facing view of the building remains at Site 88

Improved land was also identified centred at Site 88 and observed in an area in the north-eastern portion of the Site Boundary. These areas were identified on the Lidar imagery (Figure 9-9 & 9-10- Plate 6 & 8). The building at Site 88 (Plate 7) was found to be a large, dry stone structure, roughly aligned NW-SE and surviving to a maximum height of 1m. The building remains (Site 88) are located within 25m of the access track.

The building appears to have been used as a sheepfold, and evidence of fairly recent consolidation or repair was noted, although the structure no longer appears to be in use.

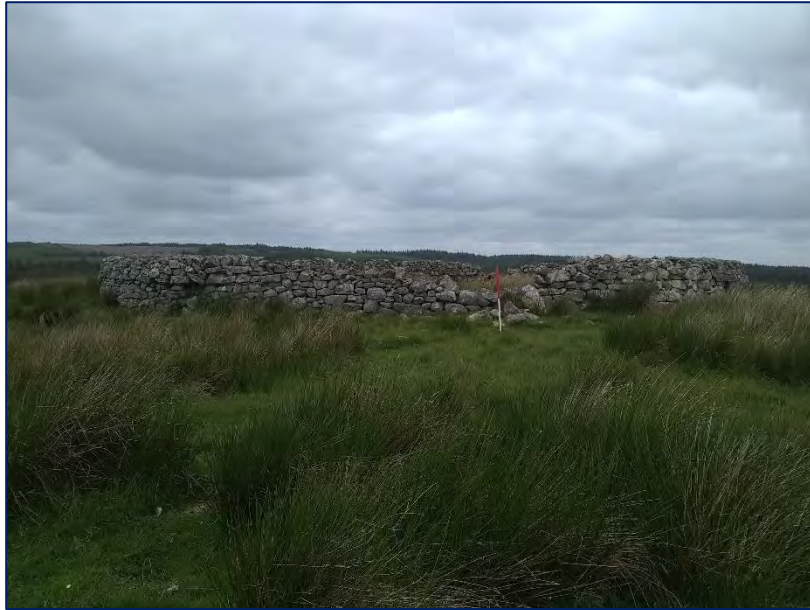
Plate 9: North facing view of potential building remains at Site 95

Another relatively flat area of land was identified to the west of Site 88 within the improved grassland. A large number of stones were identified in this area and it is thought that a small building or sheepfold/sheep pen (Site 95-Plate 9) may have been located here. It is also possible that the stone is from the building at Site 88.

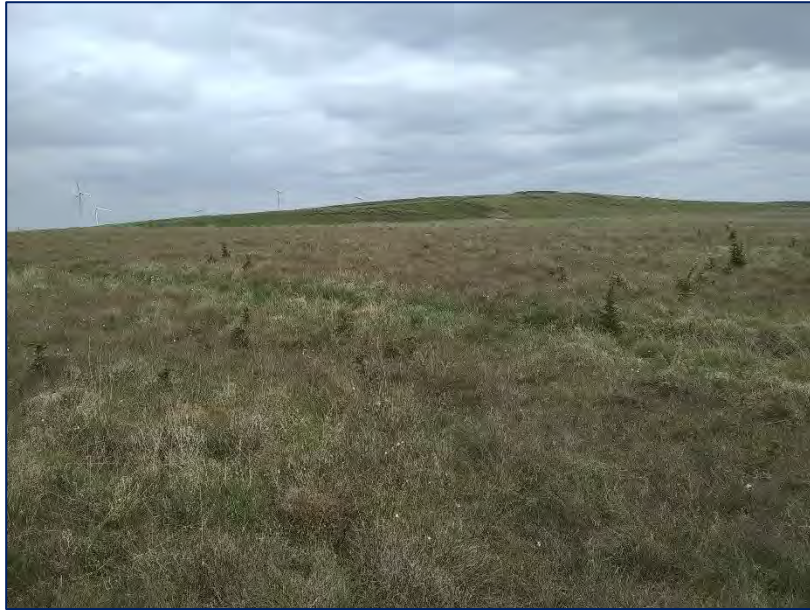
Plate 11: West facing view of the sheepfold at Site 89

A rectangular in plan, dry stone wall sheep pen was found at Site 89 (Plate 11), 106m north-east of the proposed location of Turbine 1. The structural remains survive to a maximum height of 1.2m.

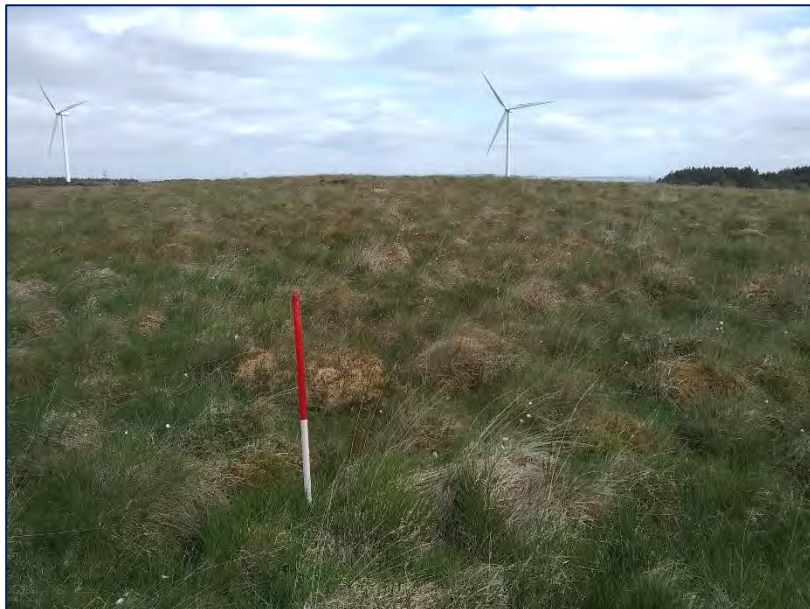
Plate 12: Northing facing view of the location of proposed Turbine 3 and a sheepfold (Site 70)

The proposed location of Turbine 3 was found to occupy an area of high, semi-improved ground, occupied by a post-medieval sheepfold (Site 70) (Plate 12). The sheepfold was found to survive as a dry stone structure with a maximum height of 1m.

The sheepfold was found to have been damaged along the eastern side. Built elements observed in the fabric of the sheepfold suggest that it was once in use as a twinning pen. Two lime clamps and a quarry (Site 71) were also recorded in the vicinity of the proposed location of Turbine 3 and were observed on the eastern side of the low rise on which Turbine 3 would be constructed.

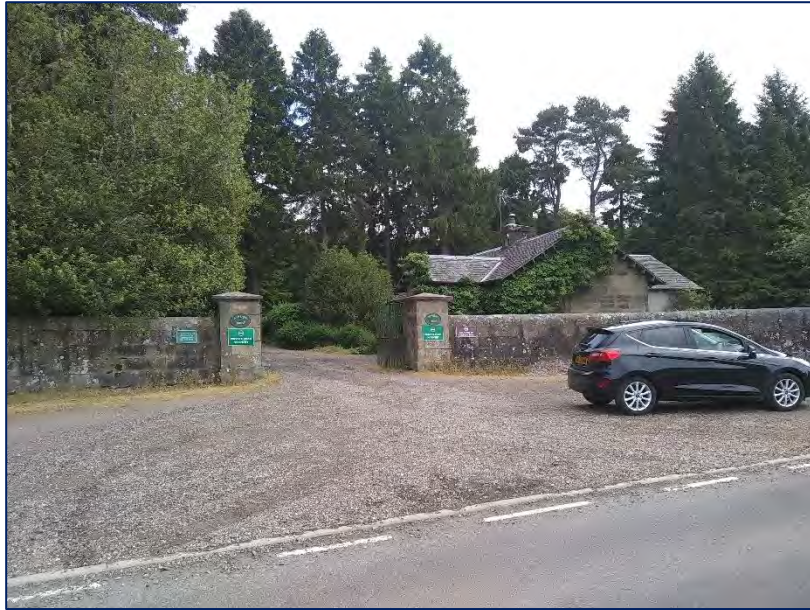
Plate 13: North facing view of the location of a former pond (Site 48) which appears to have been infilled

No evidence of the pond at Site 48 was found, although a mound was identified on the location and its possible that Site 48 has been infilled (Plate 13). The land to the east of Site 48 was found to be wet around the location of Coal Burn.

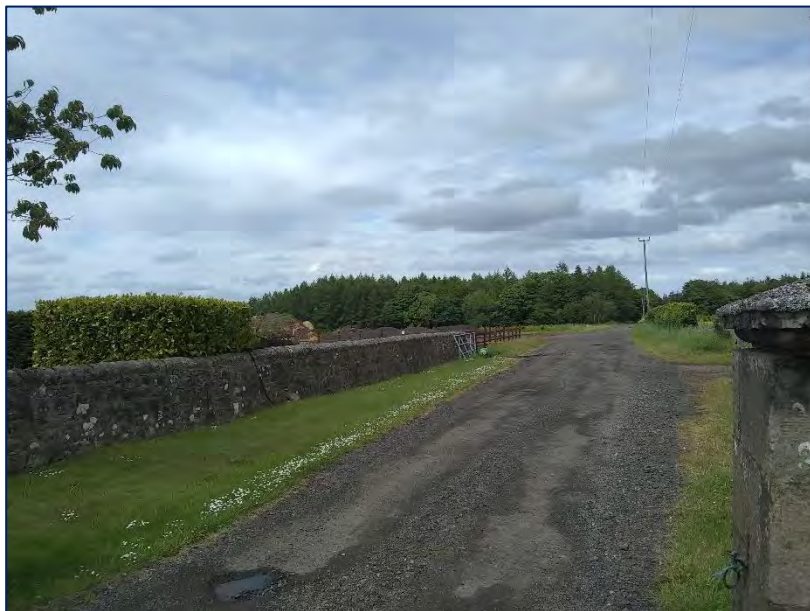
Plate 14: South facing view of the northern entrance into the Inventory Garden and Designed Landscape (GDL) of Harburn House (centred Site 29)

The northern portion of the GDL was redesigned in the mid-19th century due to the construction of the Caledonian Railway, which is located within the northern extent of the GDL, and in the modern era ponds have been added. The main designed approaches to the estate are from the north and the south (HES, 2021b- Plates 14 & 15).

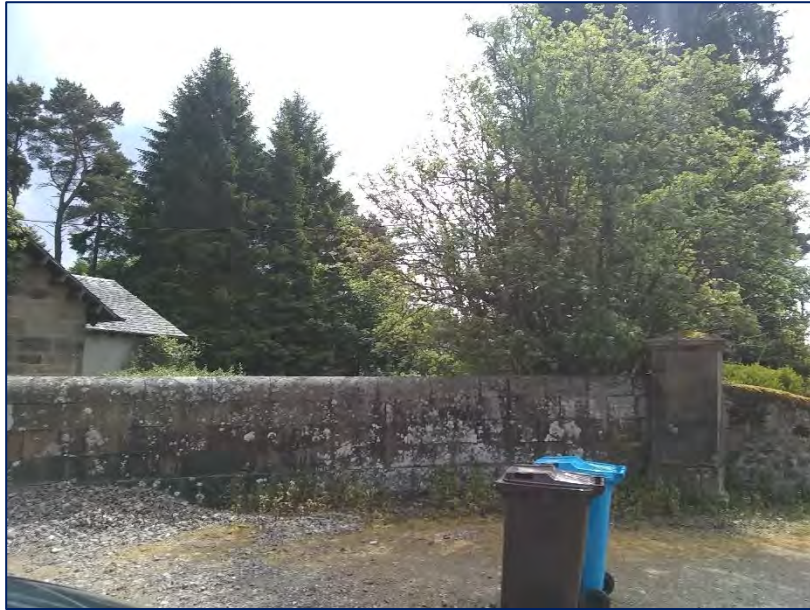
Plate 15: East facing view from the southern access to the GDL of Harburn House (centred Site 29)

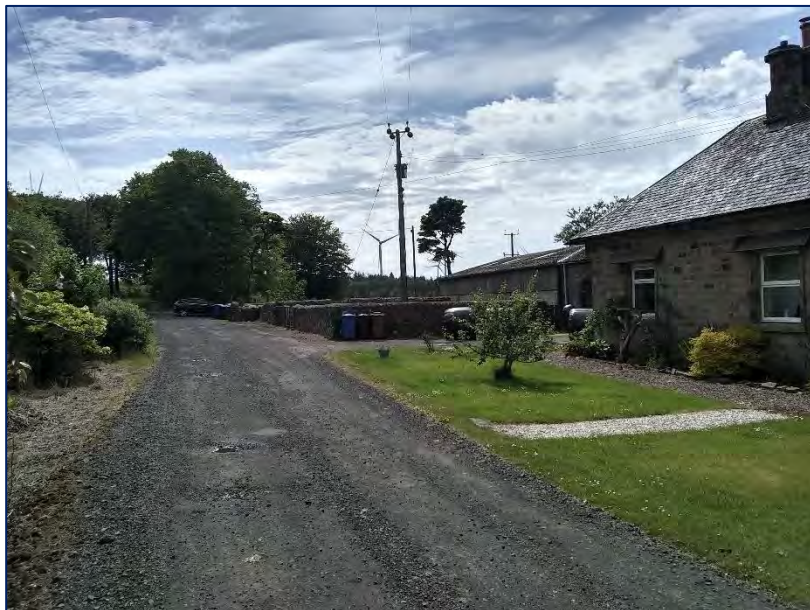
Plate 16: South-west facing view towards the Site from northern access to Harburn House (centred Site 29)

The Proposed Development would be located 5.54km south-west of Harburn GDL, in the vicinity of existing wind turbines, the closest of which consist of the existing Harburnhead and Pearie Law windfarms (see Plates 16 & 17 and Figure 9.12).

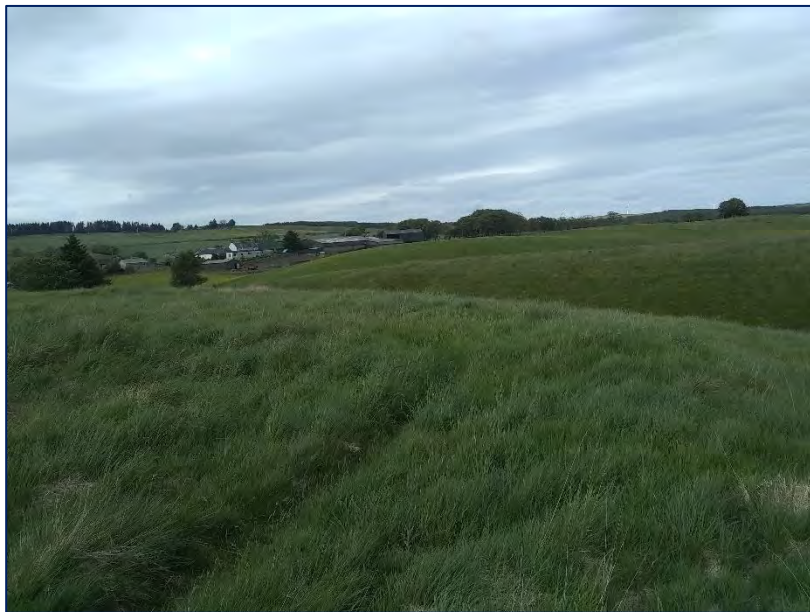
Plate 18: East facing view of the Scheduled Haywood Mining Village (Site 2)

The Scheduled remains of the deserted mining village at Haywood were visible as one upstanding structure, which has been consolidated during the relatively recent past and low earthworks which appear to be the remains of buildings on a north facing slope (Plate 18).

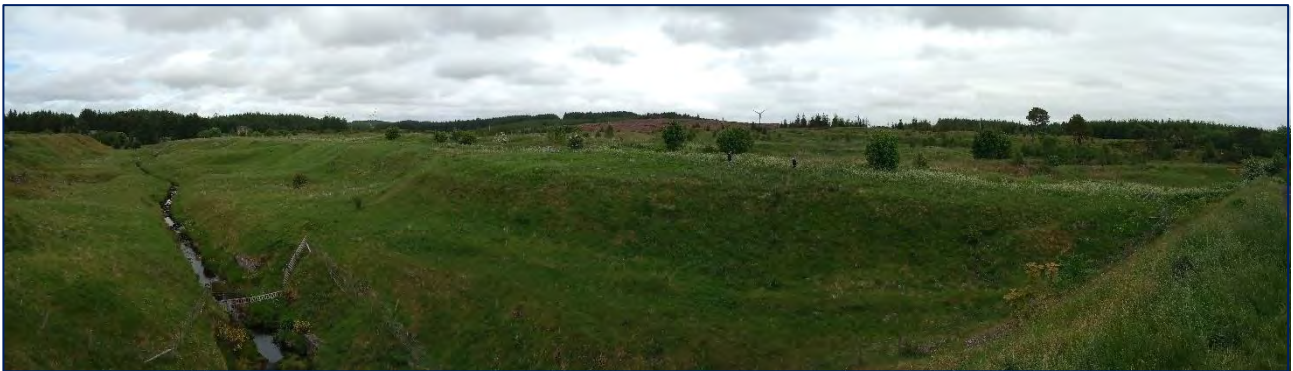
Plate 19: North facing view from the Scheduled Haywood Mining Village (Site 2) towards the Site

The Proposed Development would be located 2.37km north of the monument. Three turbines are visible to the north of the asset in the same arc of view in which the Proposed Development would be visible (see Plate 19 and Figure 9-13).

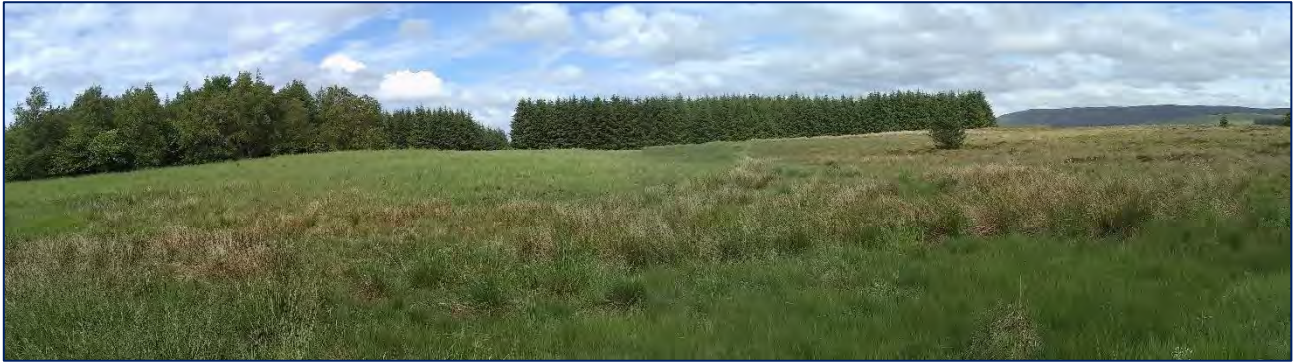
Plate 22: West facing view from the closest access to the Scheduled West Harwood, burial mound (Site 6) towards the Site

The Proposed Development would be located 3.25km to the south-west of the asset. In this direction three turbines, most likely turbines of the Pates Hill Windfarm, are already visible beyond plantation forestry (Plate 22).

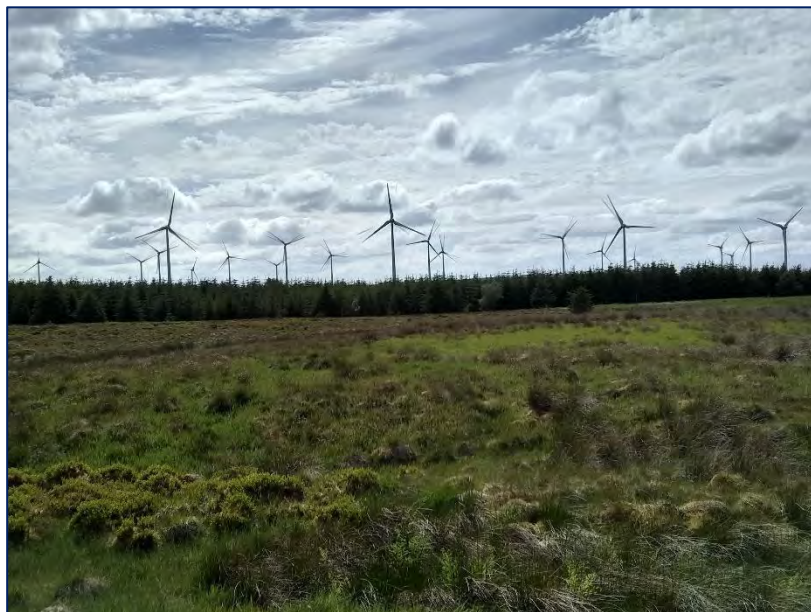
Plate 23: East facing view from the B7008 towards the Scheduled Monument on Camilty Hill (Site 9)

The Scheduled Roman fortlet (Site 9) on Camilty Hill survives as a banked earth, square in plan earthwork on a relatively flat plateau on the southern side of Camilty Hill (Plate 23). The fortlet occupies a relatively high position in the landscape with views to the south and south-east. The land to the west slopes downwards and as such the fortlet would originally have had views to the east, west and south.

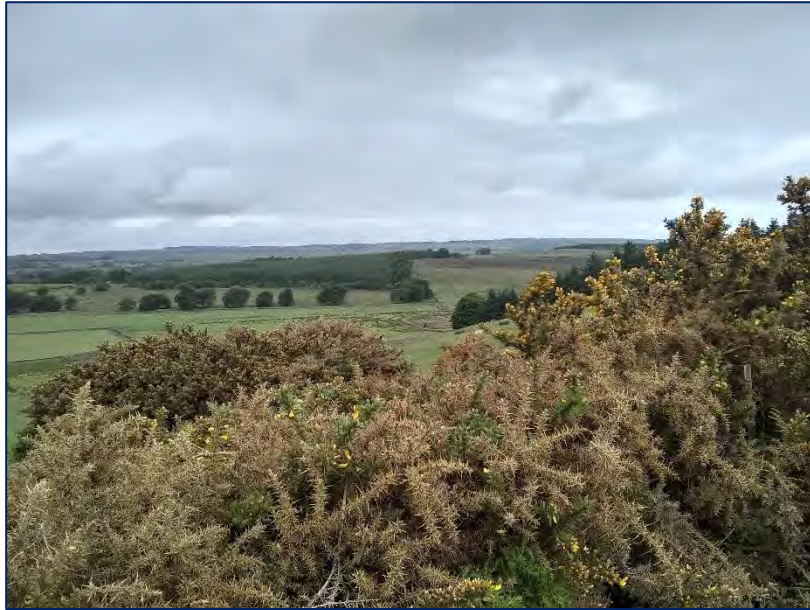
Plate 27: North-west facing view from the largest cairn at Site 77 towards the Site

The Proposed Development would be located 5.0 km north-west of the cairns (Plate 27). Turbines are already visible in this direction,

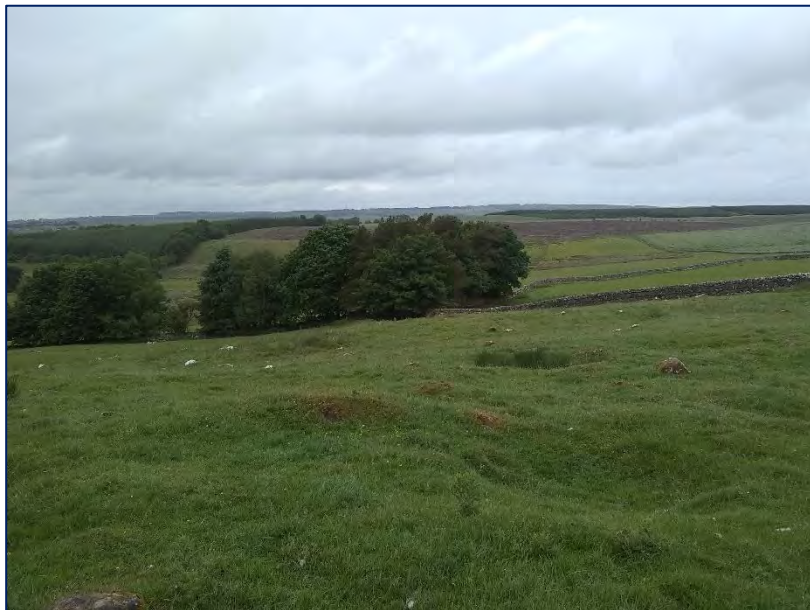
Plate 28: North facing view from the track to West Yardhouse Farm north of two Scheduled cairns (Sites 85 & 86)

The Proposed Development would be located 7.0 km north-west of the cairns (Site 85 & 86) and would be visible along a distant ridgeline, beyond the near Falla Burn valley (Plate 28).

This ridgeline is consistent and is currently occupied and broken by mature plantations and wind turbines. Whilst the Proposed Development is anticipated to be visible, given its distance from the cairns and its location beyond the ridgeline it would clearly be understood as being located well beyond the relevant setting of the cairns (Site 85 & 86), and will be seen as a distant feature.
