# Woolfords Wind Farm Tip Height Increase

Figure 6-4  
Peatland Restoration

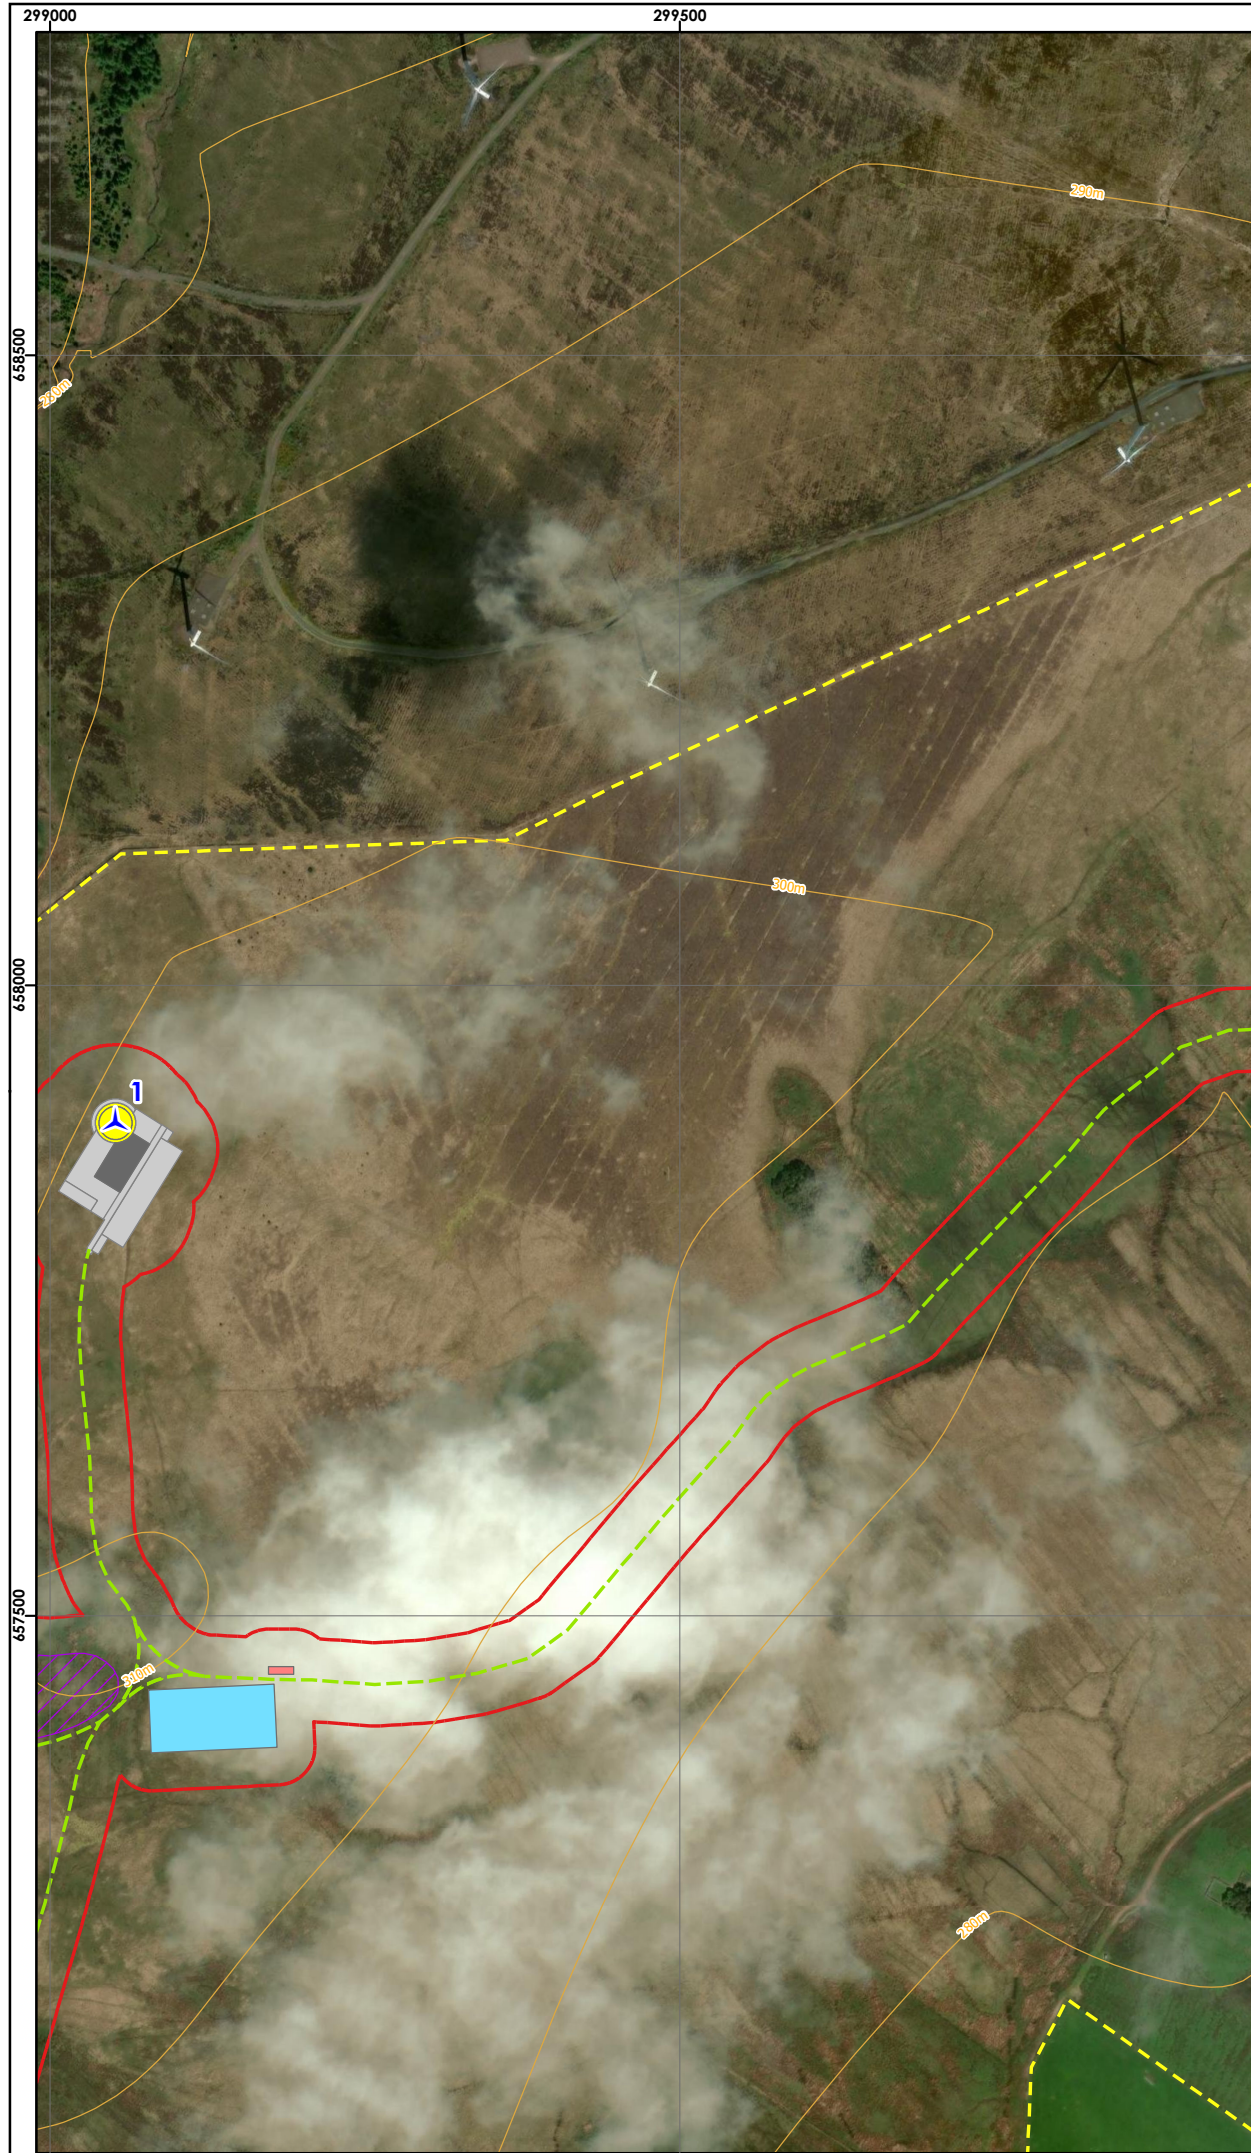
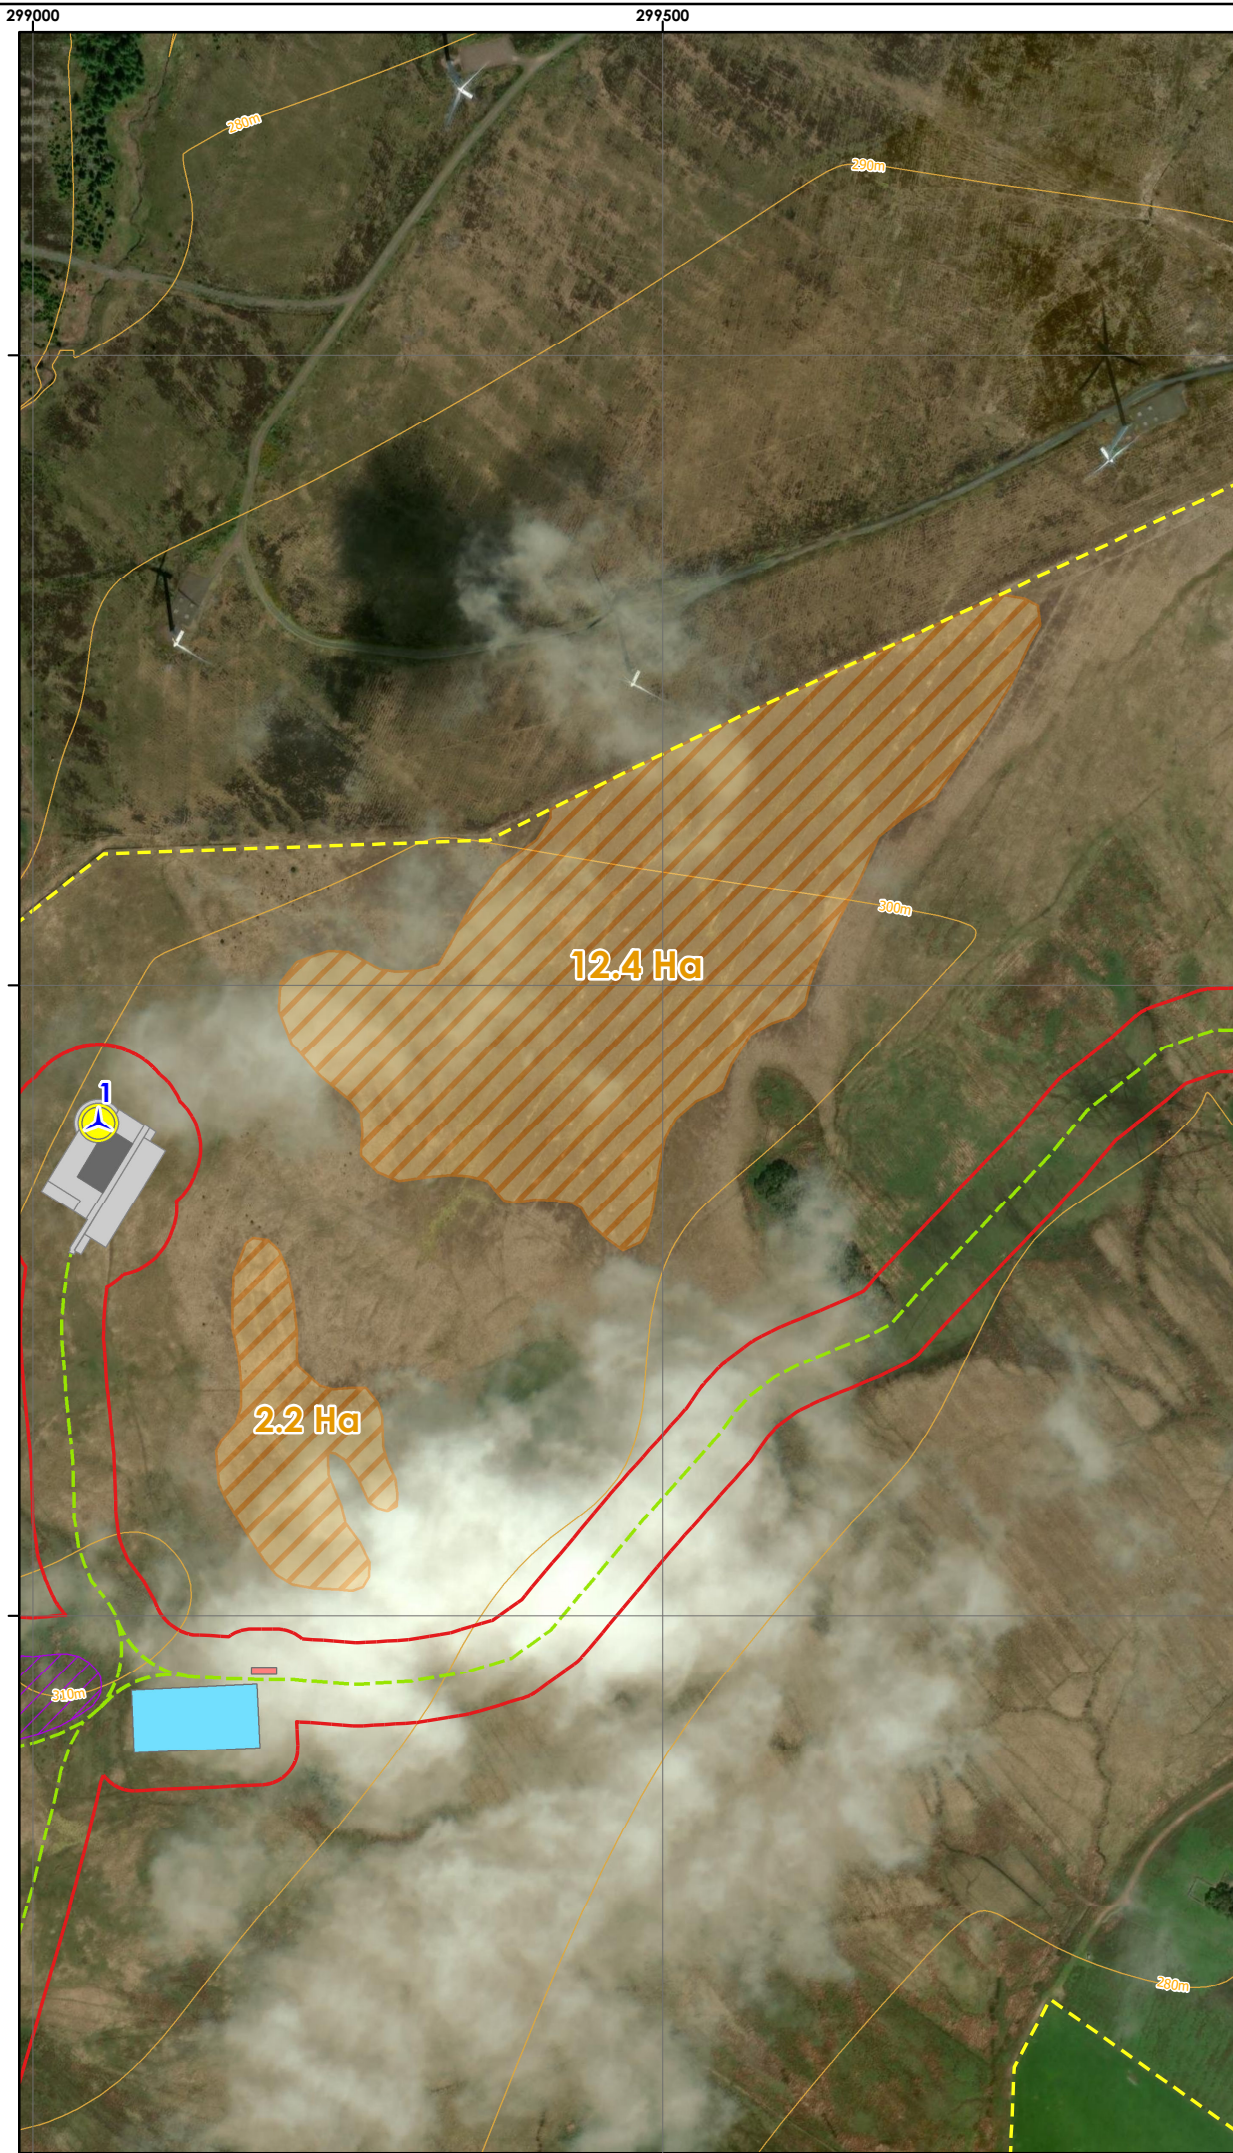
Aerial image showing extent of  
artificial drains to be wetted  
as part of restoration.
